Information pack for Rebecca Pow MP for meeting at Meverley Village Hall on 27 July 2021

This pack is based on that provided to participants in the meeting on Thursday 13 May 2021 (starting from Meverley Village Hall) arranged by Owen Paterson MP with Environment Agency staff and Severn/Vyrnwy confluence constituents (including a Shropshire Councillor, members of Meverley Internal Drainage Board and Meverley and Kinnerley Parish Councillors). The main purpose of the meeting was for the Environment Agency staff to see, and gain an understanding of, the whole local flood defence system.

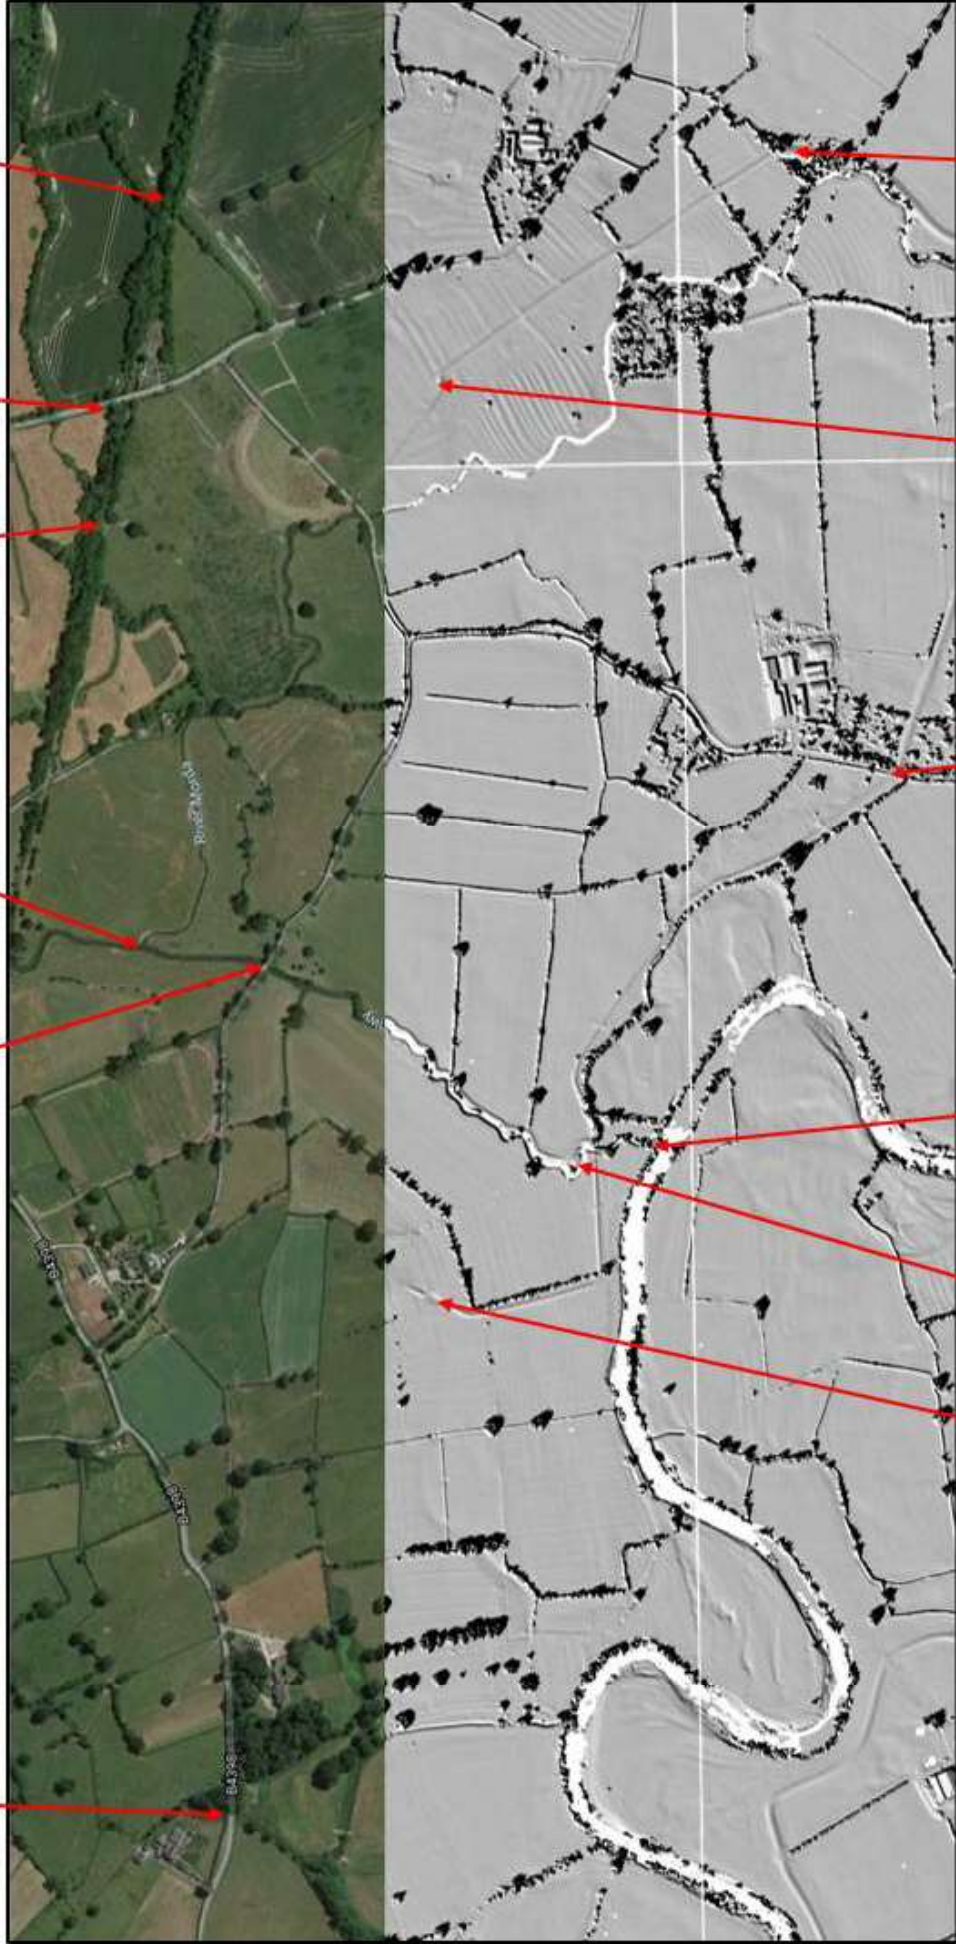
2. Ditto, southern part.
3. Detailed map of the "Morda Gap" i.e. the north-west end of the local defences, where the Vyrnwy first overflows, backs up into the River Morda, and thence flows overland to Meverley and beyond.

Wern Ddu
flood doors

River Morda
new cut bridge

River Morda
division

Flood opening in
Old Potts railway
embankment

Maesbrook
Flood Channel
gauge

Flood
opening

Collins (1940s)
argae, and gap

Gap in Morda
argae

River Morda
outflow

Dyffryd flood
doors

Pentre Perva argae has been
re-aligned subsequently to
this lidar image

Pentre Perva
flood doors ??

This "missing" section of argae was completed in the early 2000s, subsequent to this mapping

The Dunkett sluice

MIDB maintained sluice

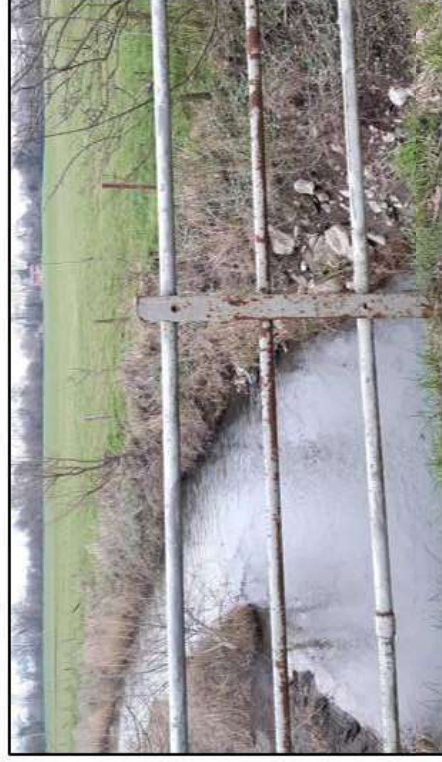
1: Normal

12. Sequence of photographs showing how the Vyrnwy waters rise and flow into the "Morda Gap".
13. Hand coloured map showing directions of flow of water as it rises through the "Morda Gap".

Morda Bridge, new cut, sequence

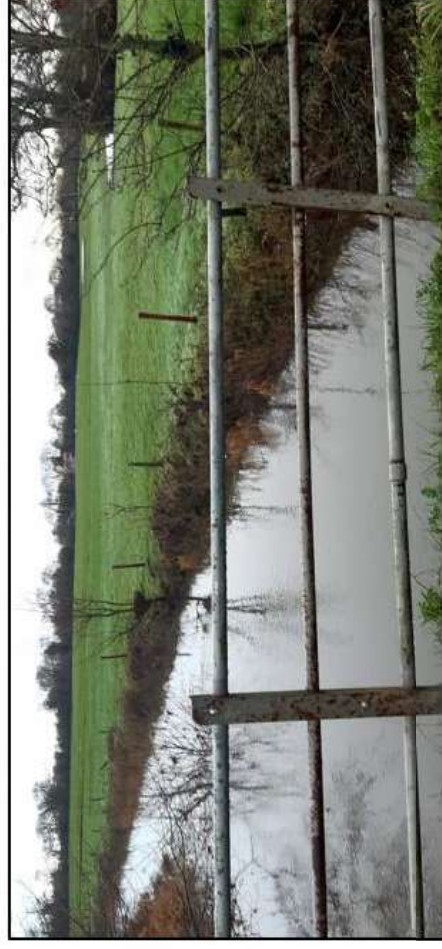
2: Backed up; all flow down Mill stream

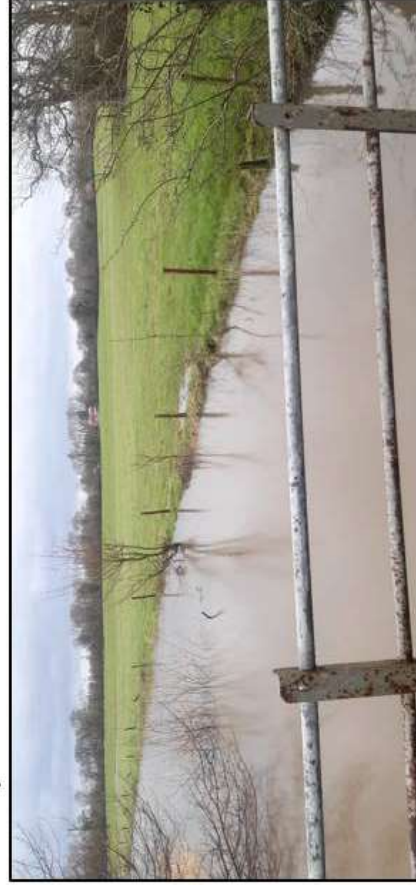
3: At point of out-of-channel flow

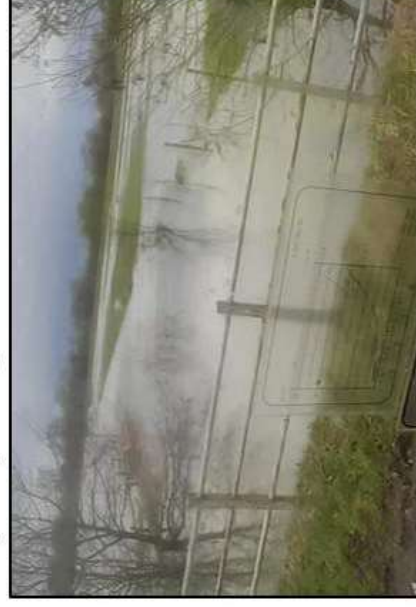
4: Vyrnwy rising more; start of overland flow

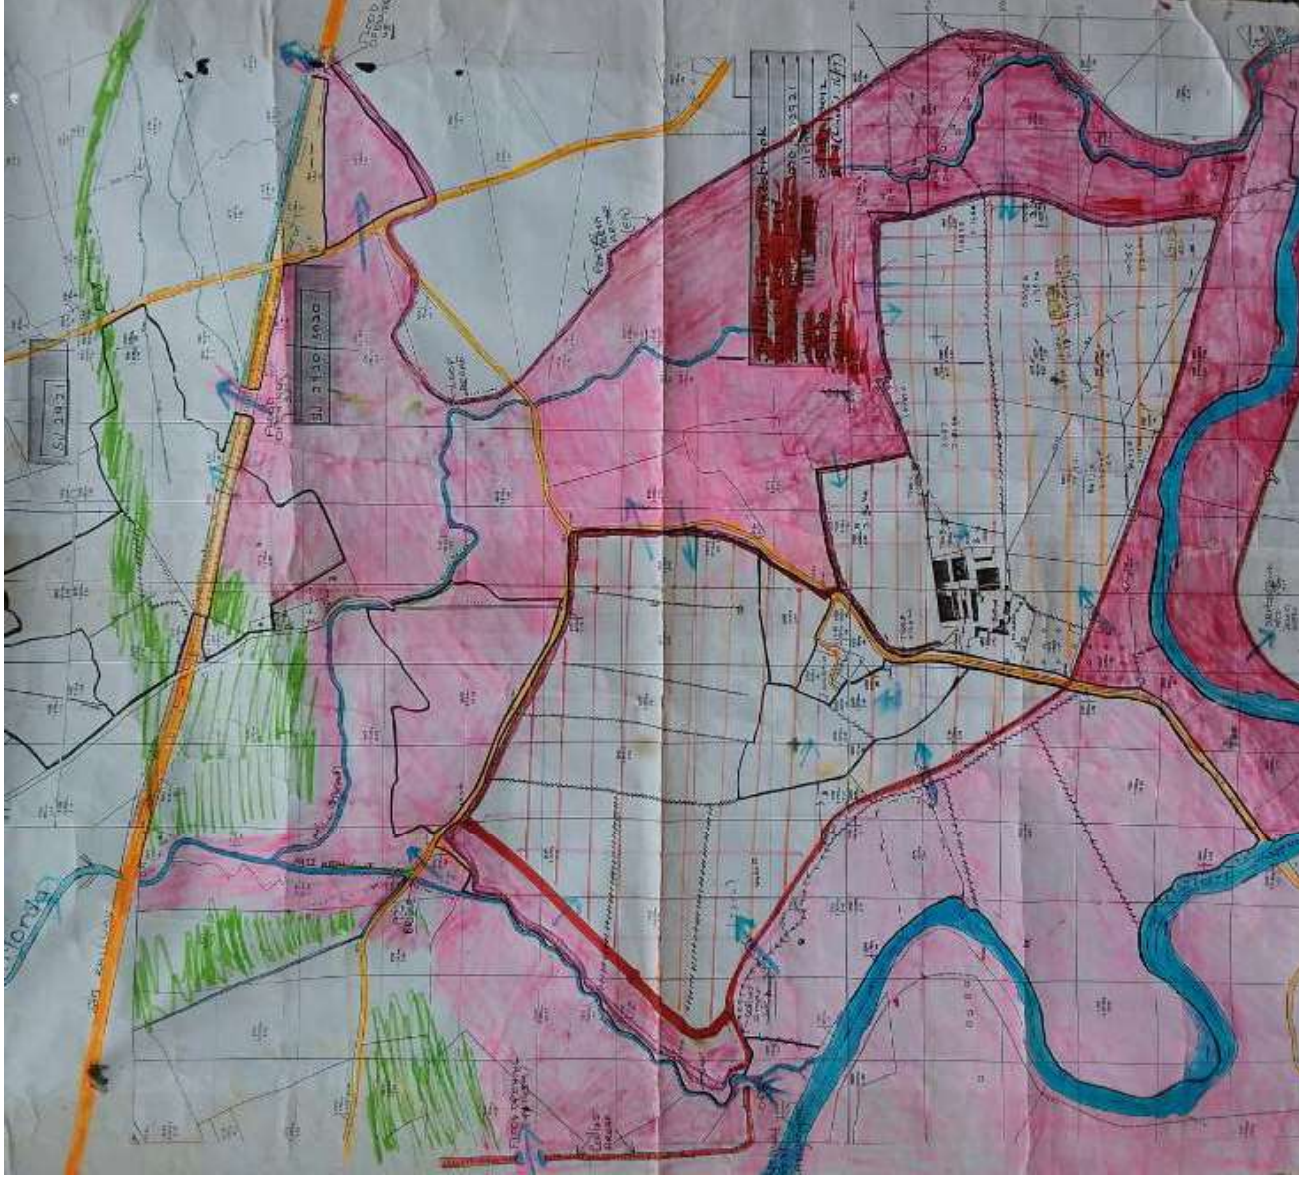
Floodwater containment at River Morda /River Vyrnwy Confluence (prior to any overtopping)
